*RM46x Microcontroller*

**Silicon Revision C**

# **Silicon Errata**

Literature Number: SPNZ219A  
March 2015–Revised October 2015

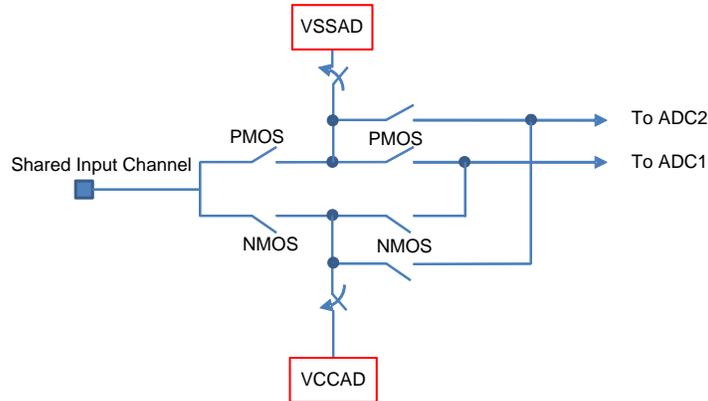
**Figure 2. Shared Input Channel in "Open" State**

**Issue** This microcontroller (MCU) has two Analog-to-Digital Converters (ADCs). Some of the input channels are unique to ADC1 while some are shared between ADC1 and ADC2. [Figure 2](#) shows a block diagram of an input channel shared between ADC1 and ADC2.

The PMOS and NMOS switches are open indicating that this shared input channel is not currently being sampled either by ADC1 or by ADC2. Also, there are switches to VCCAD and VSSAD that are closed. If any current is injected into this analog input, any leakage through the open PMOS switch will be shunted to VSSAD. These switches to VSSAD and VCCAD are opened as soon as this shared input channel is being sampled by either ADC1 or ADC2.
